## CASE HISTORY:

# Vibration Analysis On A Conveyor Drive Unit

BY MICHAEL S. JOHNSON, JR., PE

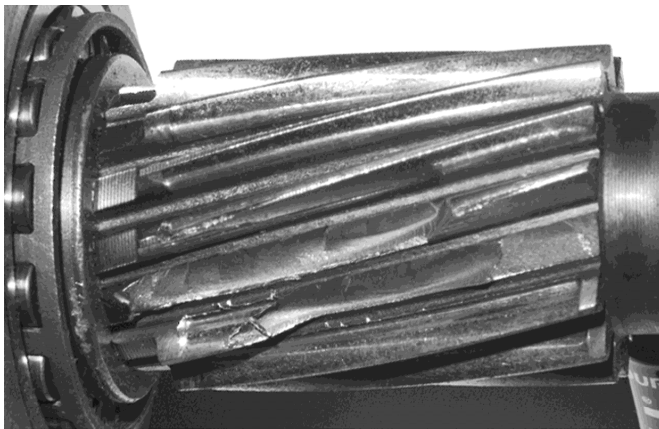
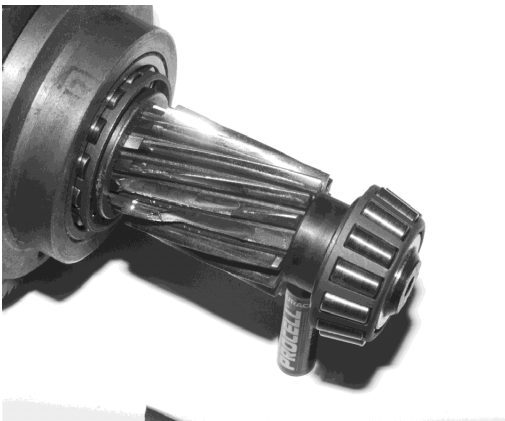
When the unit was replaced, the BMC maintenance technicians disassembled the defective gearbox and found a broken tooth on the low speed pinion. The broken tooth was causing an impact each time it meshed with the gear on the output shaft. The tooth next to the broken tooth also had a severe crack and came off when handled by the analyst. The photographs show the intermediate shaft on the left and the broken teeth on the right.
